# Temporomandibular Joint (TMJ) Implant Retrieval Study

Maria Alfaro  
Shelley Kerwell

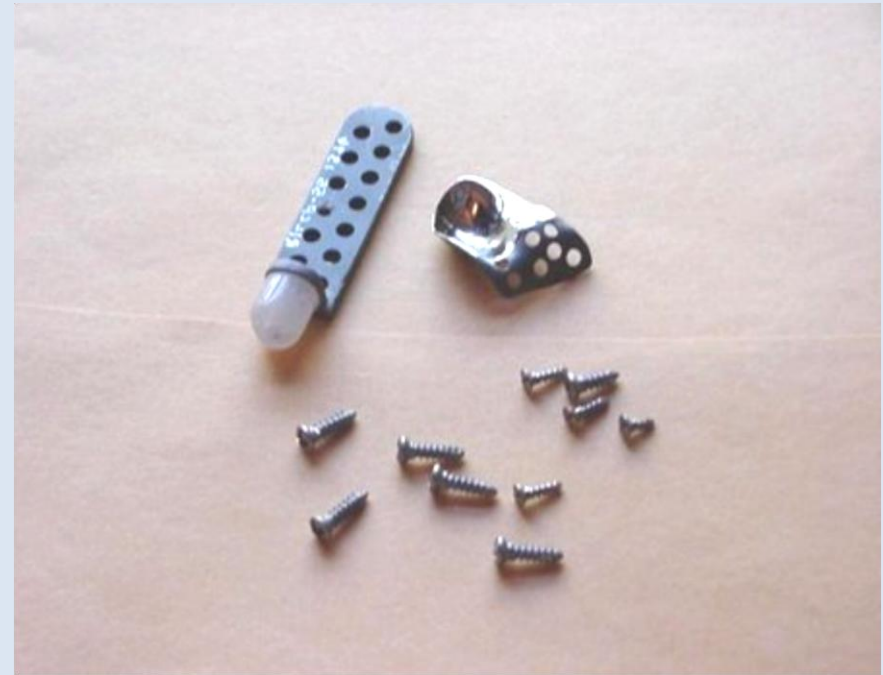
- TMJ TJR
  - 1,000-2,000 replacement surgeries/year in the US [2]
  - Implants expected to last 5 years, but replaced in 3 years [3], unlike hip replacement ( $\approx 15$  years)
  - In order to compare failure mechanisms evaluation of all TMJ TJR that have been/currently employed:

MoM, MoP, and TiNi Coated
