IBTN-USA

*“In vitro Comparison of Head-Neck Taper Junction
vs. Bone-Stem Interface Fretting Corrosion in a Total
Hip Arthroplasty Model”*

2/21/14

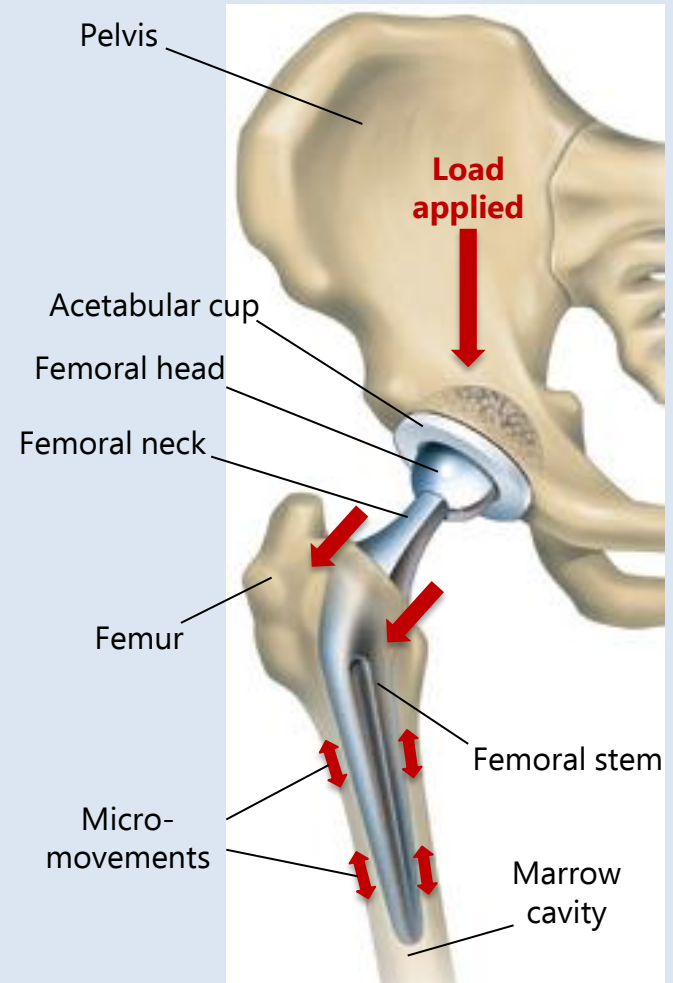
Cyclic loading
Small amplitude
movements (1-100 μ m)

Synovial fluid

DEGRADATION of the
material

- Release of metal ions and wear debris
- Inflammation
- Osteolysis
- Crack initiation
- Loosening of the implant

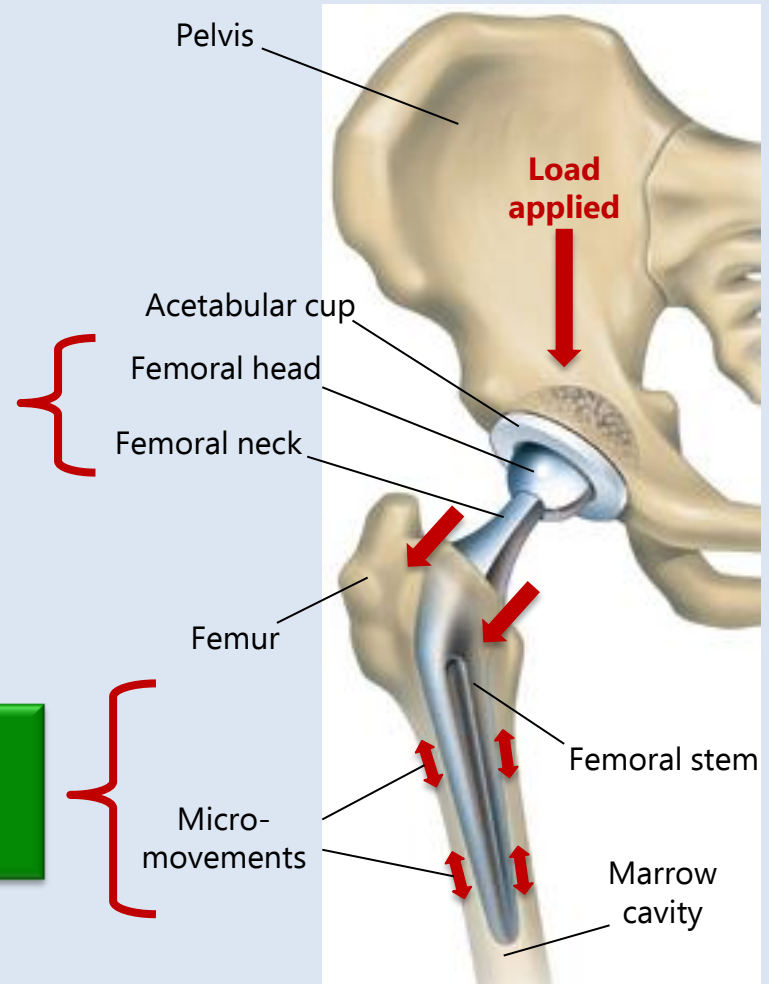
Modular
Junctions
(Head-Neck
interface)

Bone-Stem
interface

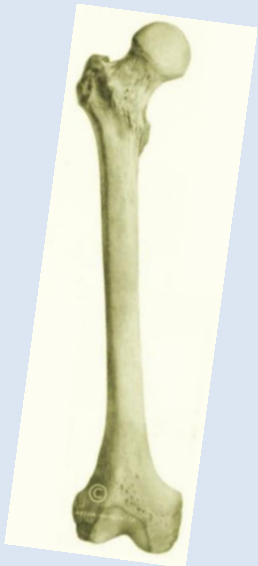
Porcine femur bone

- Cut epiphysis
- Drill a hole in the marrow cavity ($\text{\O}:18.5 \text{ mm}$)

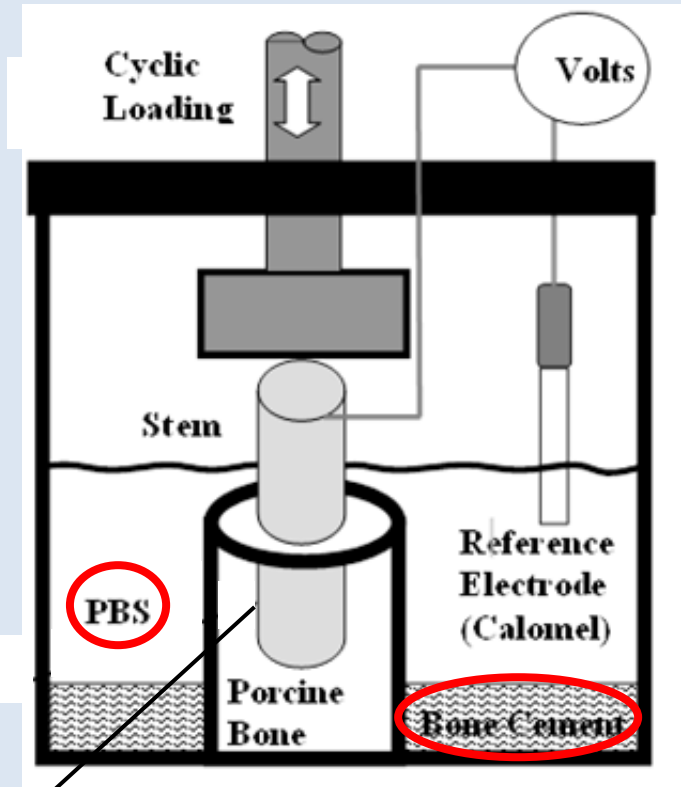
Ti6Al4V rod
 $\text{\O}:18.5 \text{ mm}$

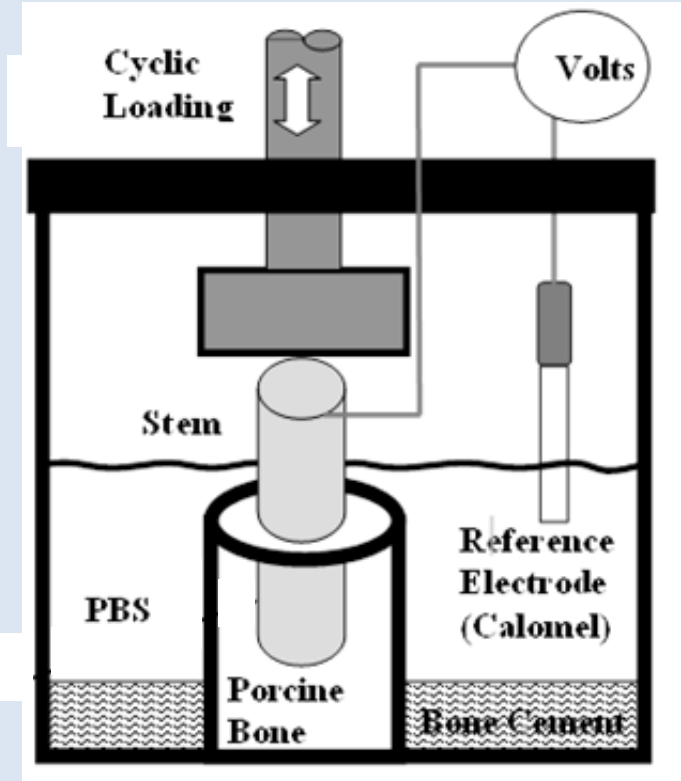
- **Insertion test:**
 - Rate of 10mm/min up to 2cm press fit
 - 8800 Instron test frame
- **Cyclic loading test:**
 - **Stage (1):** low load (100N-500N)
 - **Stage (2):** higher loads (500-2000N)
- **Electrochemical measurements:**
 - Open circuit potential (OCP)
 - WE - Ti6Al4V rod
 - RE - SCE

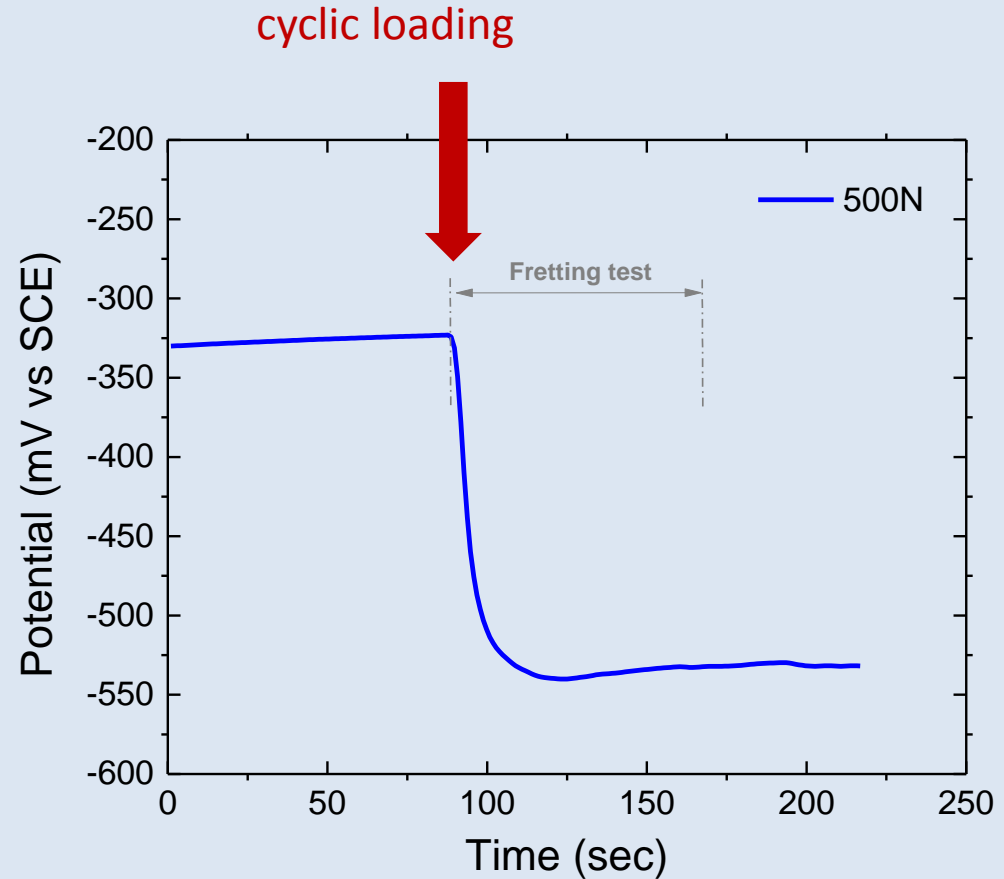
Evolution of potential:

Potential (voltage)
drop induces fretting
corrosion

OCP drop
215mV

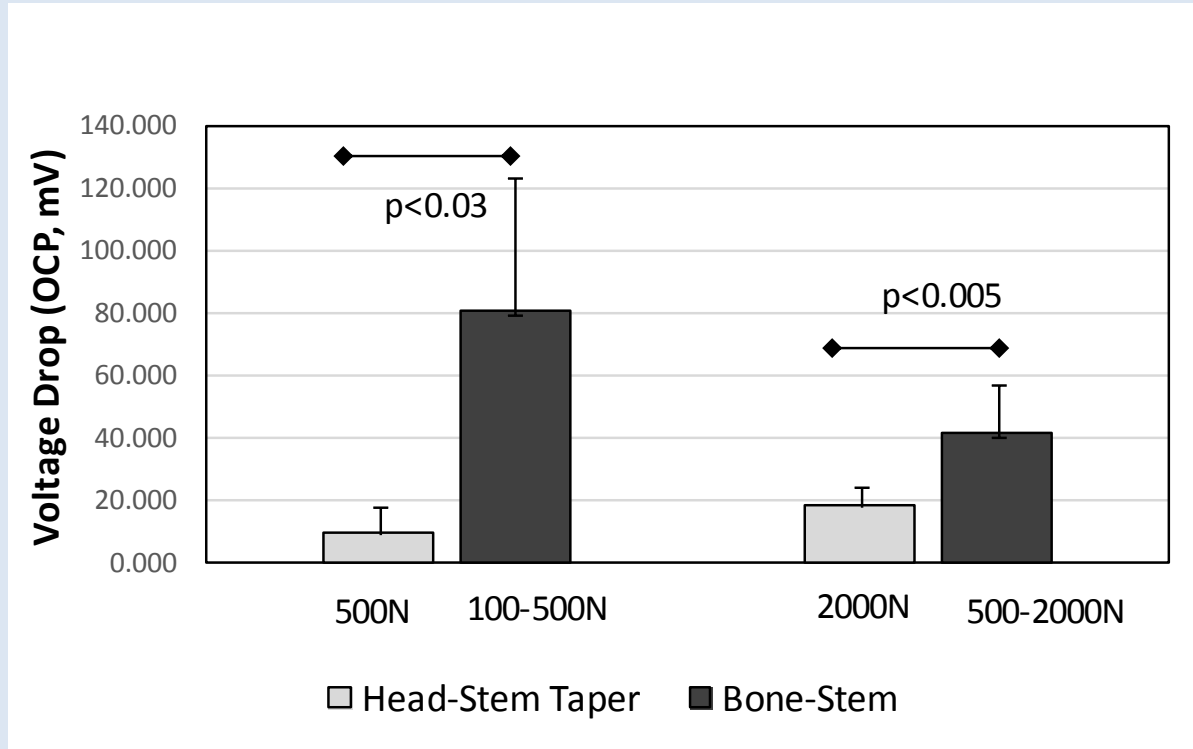
Potential drop: head-neck* vs. bone-stem

Fretting-corrosion at the **Bone-Stem interface** was significantly greater than at the Head-Neck taper junction.

- **Hypothesis** supported.
- **Press-fit into femoral bone**: free potential behavior is strongly dependent on the unique morphology of the bulk bone and the unique contact areas of Ti6Al4V stem.
- Amount of fretting-corrosion at the bone-stem interface is higher than that previously reported for metal-on-metal taper junction [1].
- The identification of fretting-corrosion behavior at **two locations** of hip implants may indicate critical instability of the electrochemical system, where the **synergistic interaction** of fretting and corrosion may accelerate degradation mechanisms in some patients.
